# EICA Report of the Great East Japan Earthquake Investigation

April 2012

GREAT EAST JAPAN EARTHQUAKE INVESTIGATION COMMITTEE  
THE SOCIETY OF ENVIRONMENTAL INSTRUMENTATION,  
CONTROL AND AUTOMATION (EICA)

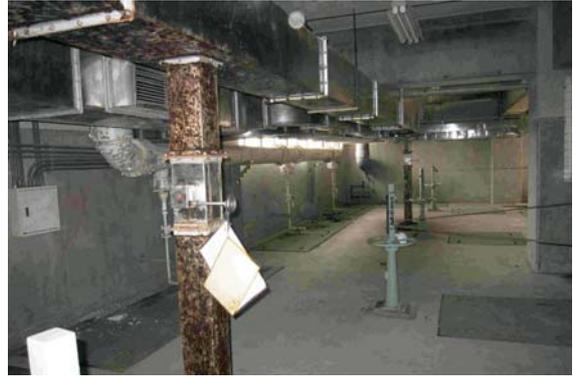
**Photo. 2.4** Upper part of the indoor biological reactor tank on the 2nd floor (Photo taken in Nov. 2011)  
No significant damage to the building structure was found.

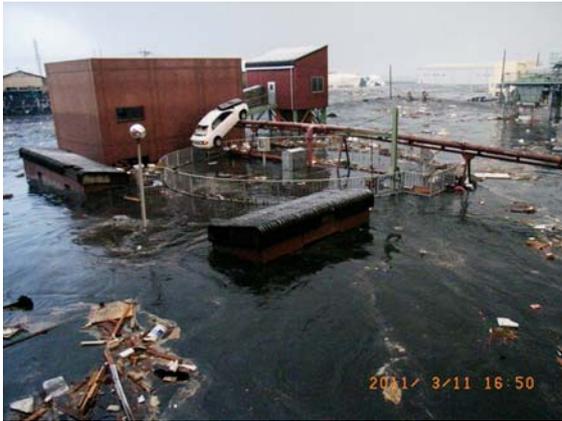
**Photo. 2.2** The moment when the tsunami hit (Photo taken by staff member at the sewage treatment plant in Mar. 11, 2011)

Inundated up to GL (Ground Level) 6 m (above the 2nd floor level of the 1<sup>st</sup> sedimentation tank)

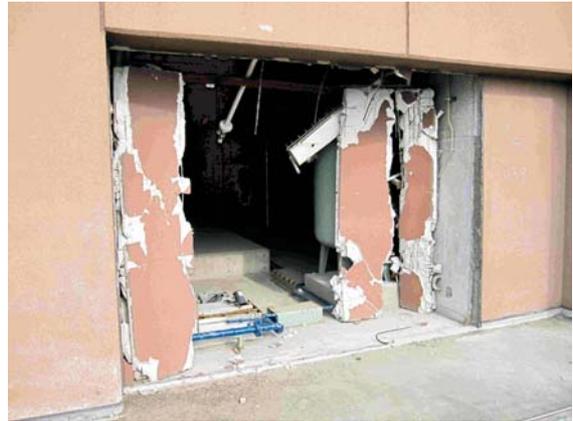
**Photo. 2.5** Equipment carry-in entrance on the 2nd floor (Photo taken in Nov. 2011)  
The backfilled section of the equipment carry-in entrance was destroyed by Tsunami.

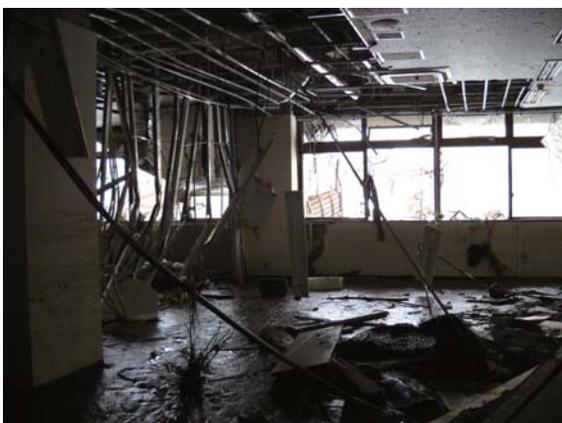
**Photo. 2.3** Interior of the administration building on the 1st floor (Photo taken by staff member at the STP in Mar., 2011)

The ceilings, etc. were inundated and destroyed.

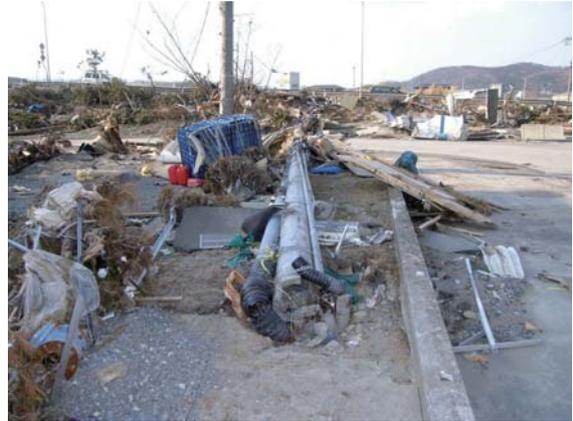
**Photo. 2.8** The destroyed NTT (Nippon Telegraph and Telephone Corporation) service leading-in pole (Photo taken by staff member at the STP in Mar. 2011)  
The power receiving wire pole was destroyed by the Tsunami.

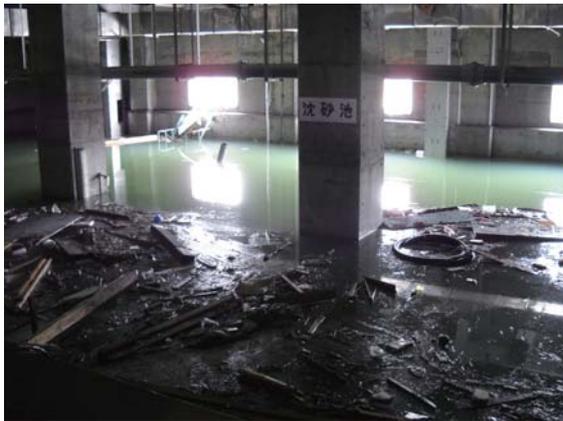
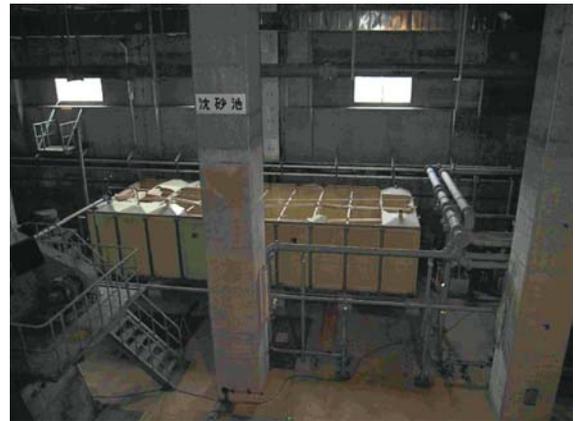
**Photo. 2.9** Grit chamber on the basement floor

Above : Immediately after the Tsunami. Submerged in water because it was installed on the basement floor. (Photo taken by staff member at the STP in Mar. 2011)  
Below : Under restoration work after water was drained (Photo taken in Nov. 2011)

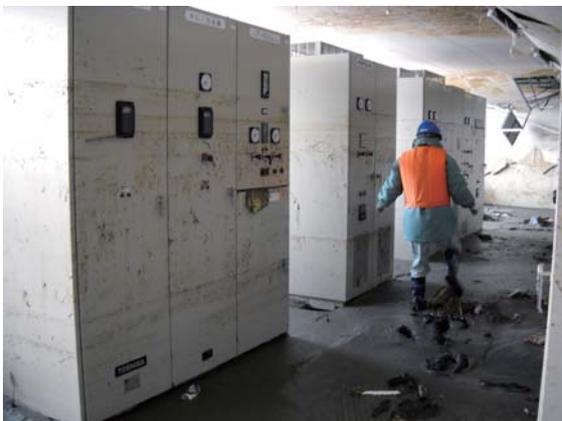
**Photo. 2.10** Electrical room in the dehydrator building area (Photo taken by staff member at the STP in Mar. 2011)  
Inundated because it was installed on the 1st floor

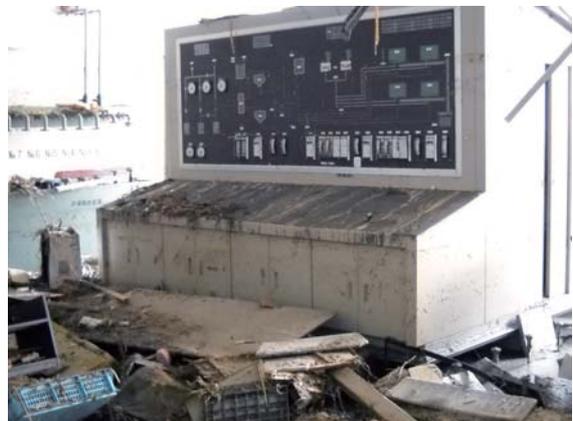
**Photo. 2.11** Submerged sludge-treatment monitoring room on the 1st floor (Photo taken by staff member at the STP in Mar. 2011)  
Inundated up to ceiling level by the Tsunami

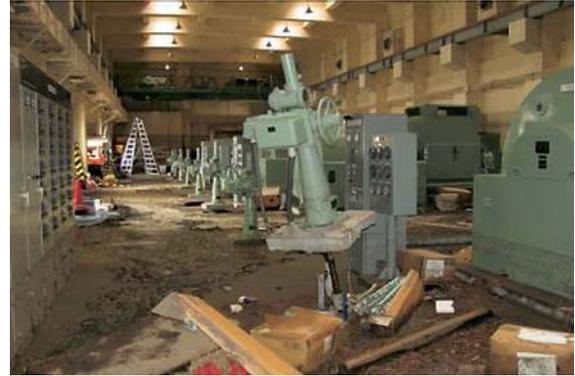
**Photo. 3.4** Damaged blower equipment (Photo taken by staff member at the STP in Mar. 2011)

Lifted and destroyed due to the buoyant force applied to the air header pipe

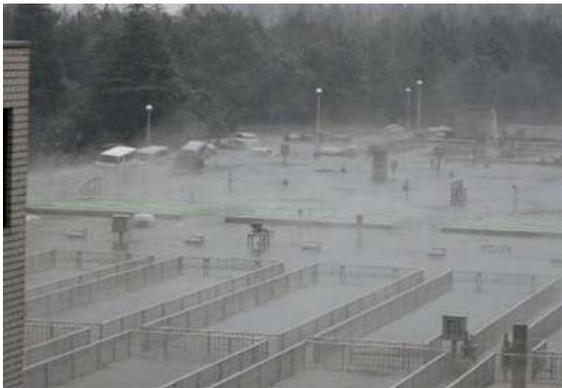
**Photo. 3.2** Tsunami upon hitting the area (Photo taken by staff member at the STP in Mar. 11 2011)

The tsunami height was GL 1.3 m on the water-treatment side and GL 2.8 m on the sludge-treatment side.

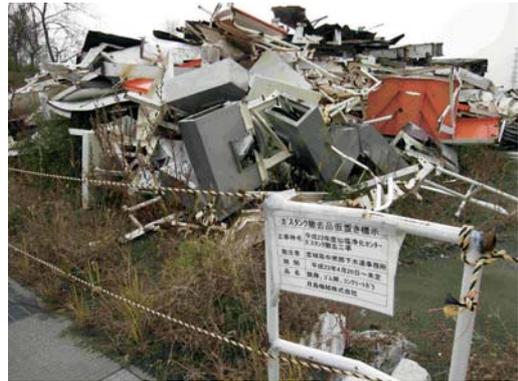
**Photo. 3.5** Temporary storage yard for the disassembled digestion tank (Photo taken in Nov. 2011)

The tank, which was destroyed by Tsunami, was disassembled and placed temporarily in this yard.

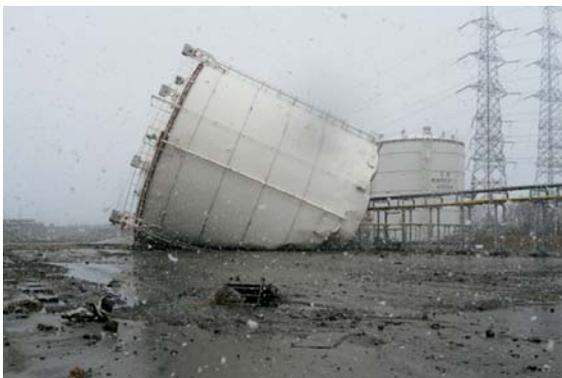
**Photo. 3.3** Toppled digestion gas tank (Photo taken by staff member at the STP in Mar. 2011)

The gas tank was toppled due to the buoyant force of the sea water.

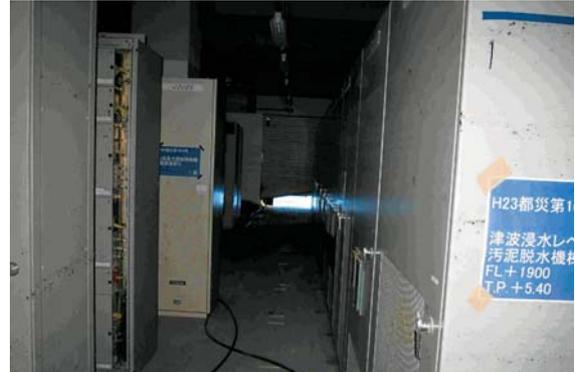
**Photo. 3.10** Tsunami trace in the electrical room on the 1st floor of the sludge treatment building (Photo taken in Nov. 2011)

The water level can be estimated by the flood trace.

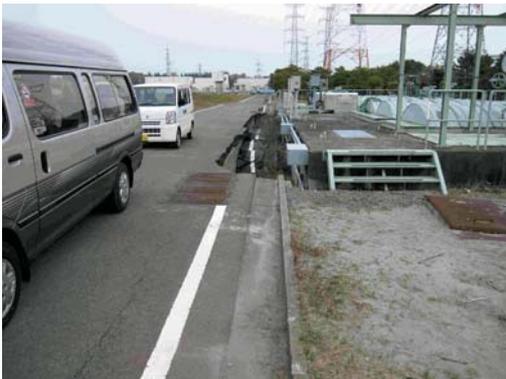
**Photo. 3.8** Caved-in road within the facilities because of ground liquefaction (Photo taken in Nov. 2011)

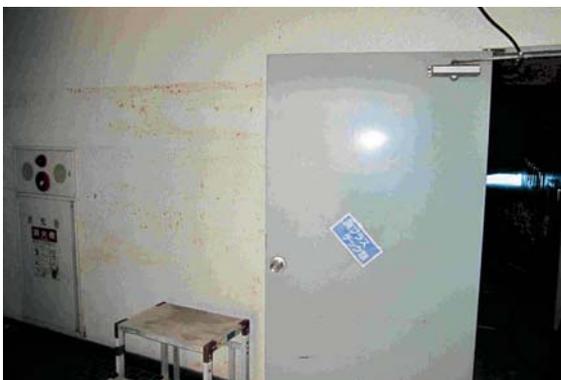
**Photo. 3.9** Tsunami trace on the electrical room entrance on the 1st floor of the sludge treatment building (Photo taken in Nov. 2011)

The water level can be estimated by the flood trace.

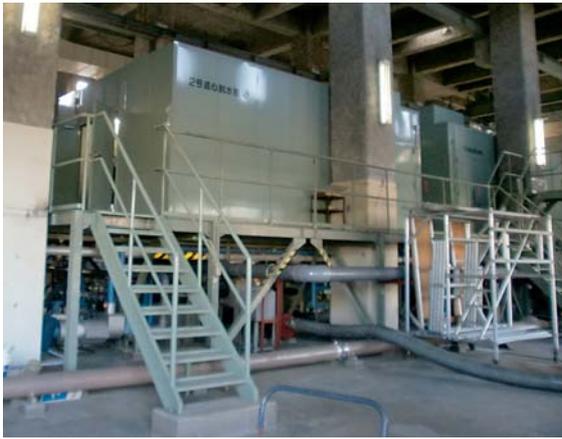
**Photo. 3.13** Centrifugal dehydrator installed on the high frame  
(Photo taken in Nov. 2011)  
Not inundated because installed at elevation, but auxiliary equipments were broken

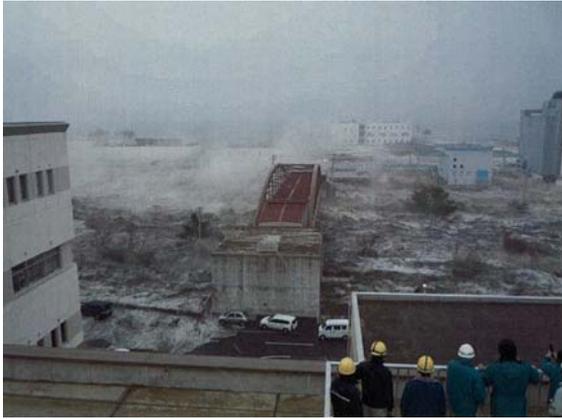
The damage due to the earthquake was rather small, but the Tsunami that came in 30–40 minutes after the earthquake damaged most of the electrical and mechanical facilities on the 1<sup>st</sup> floor and the basement. Then the function of STP was stopped. (Photo. 4. 2)

**Photo. 4. 2** Tsunami attack (Photograph taken in Mar 2011)  
(Provided by Sendai city)

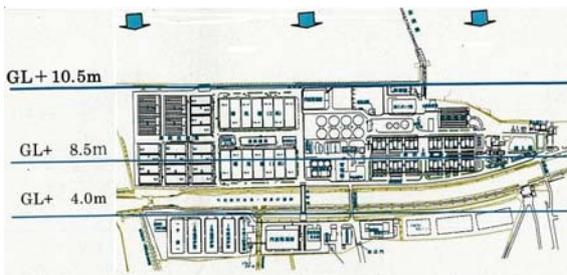
The tsunami wave reached 10.5 m from ground level (G.L), (Tokyo bay Point average level (TP) +12.85 m) at its peak near the closest area to the coast, and G.L. 4 m (TP+6.9 m) around the area just across the Teizan canal. (Fig. 4. 1)

**Fig. 4. 1** Flood level (Provided by the STP)

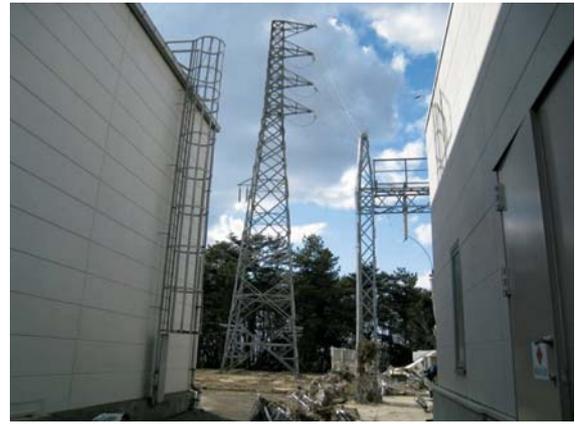
**Photo. 4. 3** Electrical towers. (Photograph taken in April 2011)  
The electrical tower withstood the Tsunami attack. It did not collapse and was not damaged.

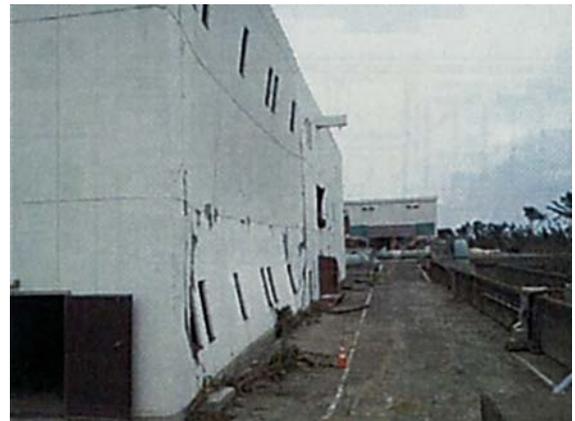
of the STP were largely damaged by the Tsunami. The wall of the main pump building was bent, and the walls of the air blower building were destroyed and cracked open by the impact of the Tsunami. The distribution panels and operator control panels placed in the building were mostly flooded and lost their function due to the impact. (Photo. 4. 4, Photo. 4. 5)

**Photo. 4. 4** Wall of the main pump building. Tsunami came and struck the building from the right side in the photo and bent the wall

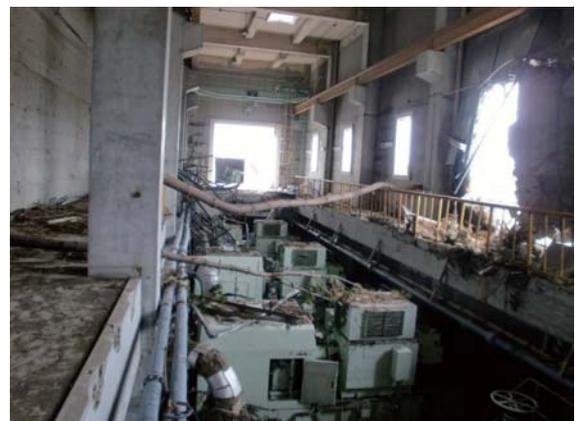
**Photo. 4. 5** Inner part of the air blower building. Air blower and electric motors were covered with the rubble that entered from the destroyed wall

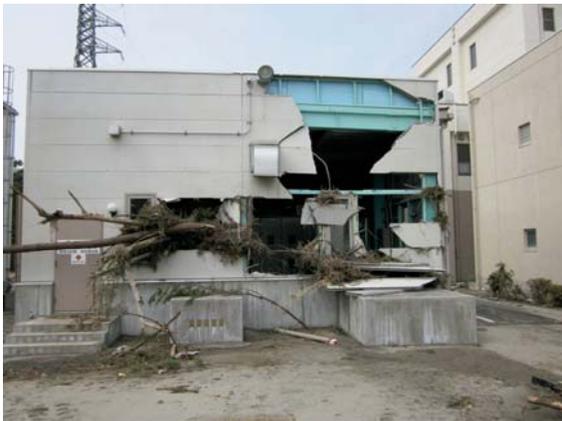
Main mechanical facilities such as dehydrators installed on the 2<sup>nd</sup> or higher floors were not directly damaged, but operation of some equipment were suspended due to the submergence of auxiliary machines on the 1<sup>st</sup> floor. The wall of the housing for the high voltage power was largely damaged by collision of drift wood, this may be because of structural weakness, the distribution panels inside had collapsed due to the impact and submerged and broke down. (**Photo. 4.6**)

**Photo. 4.6** Housing for the high voltage power  
Largely damaged wall because of drift wood.

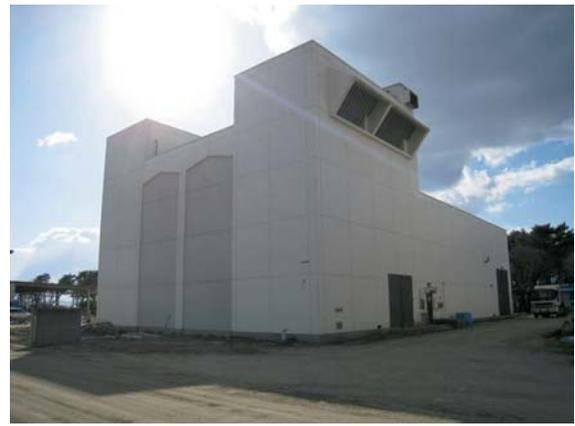
The cable duct and cooling pipe of the emergency generator were partially damaged by the earthquake, but there was no damage and no flood in the building. This is because the tsunami height was low in this area, the structure of the building was firm, secured with the sound insulation and elimination of vibration, and the housing adopted an airtight structured door and no windows. (**Photo. 4.7**)

**Photo. 4.7** Housing of the emergency generator facility (Photograph taken in Apr.2011)  
Major damage could not be seen on this building.

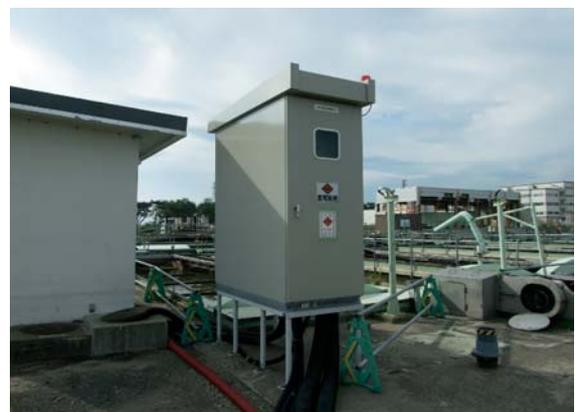
**Photo. 4.8** Temporary receiving power unit 6.6 kV installed on the primary sedimentation tank. (Photograph taken in May 2011)

It started to receive electrical power (6.6 kV/1.998 kW/1 line) from Tohoku Power Company as backup power supply from the middle of May 2011. In accordance with the restoration of the mechanical facilities such as automatic settling basins, sedimentation tanks, sludge pumps, and centrifugal dehydrators, the power had been fed sequentially and sludge treatment was reopened. (**Photo. 4.8**)

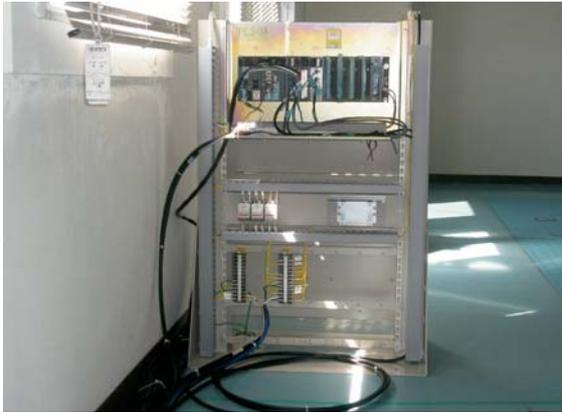
**Photo. 4.9** Temporary sludge treatment controller (Photograph taken in May 2011)  
It is installed in the electric room on the 4<sup>th</sup> floor of sludge treatment building.

For emergency recovery of existing centrifugal dehydrator, 2 controller units were installed temporarily, and additionally the undamaged auxiliary relay panels and control panels were used. This enabled the operation of the facility. (Photo. 4.9)

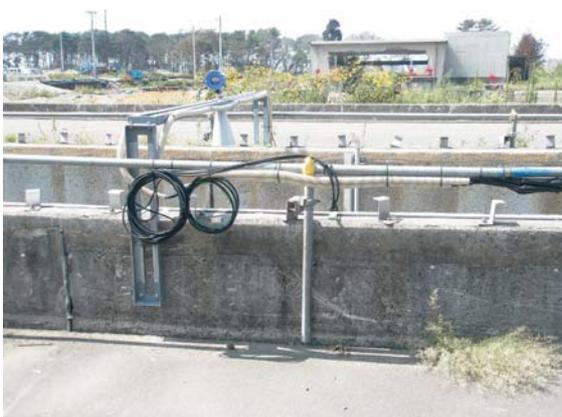
**Photo. 4.10** Temporary inflow meter (Photograph taken in April 2011)  
It is installed temporarily at the inlet of the STP.

Since the sewage flows by gravity without pumping and also water level gauge of pump well and pressure gauge for control were unnecessary, inflow meter for monitoring (ultrasonic wave pulse Doppler method) was preferentially recovered temporarily. (Photo. 4.10)

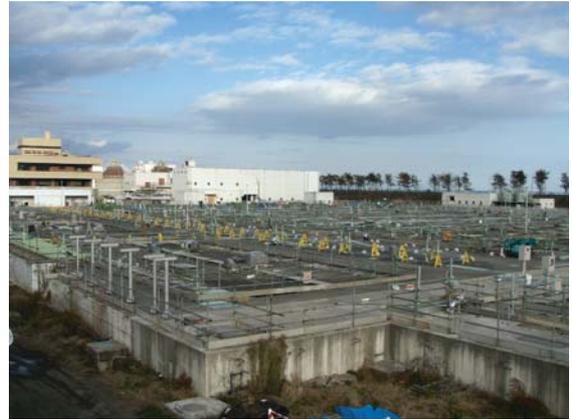
**Photo. 5.4** Restoration status of destroyed upper part of water treatment facilities (Photo taken in Dec. 2011)

Treatment by standard activated sludge process was partially restarted

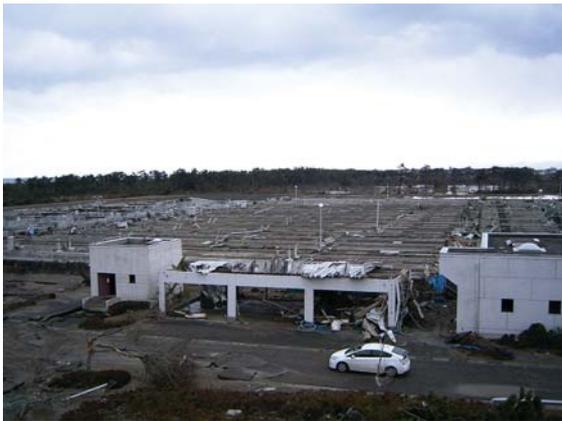
**Photo. 5.2** The destroyed upper part of the water treatment facilities (Photo taken in Apr. 2011)

The facilities was directly hit by the Tsunami

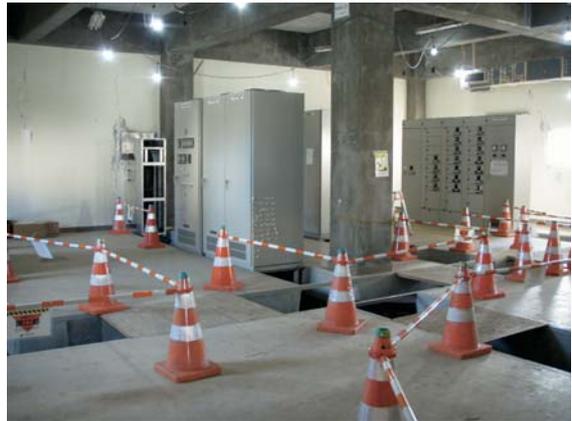
**Photo. 5.5** Restoration status of local electrical room (Photo taken in Dec. 2011)

Restoration of the sand-filtration system

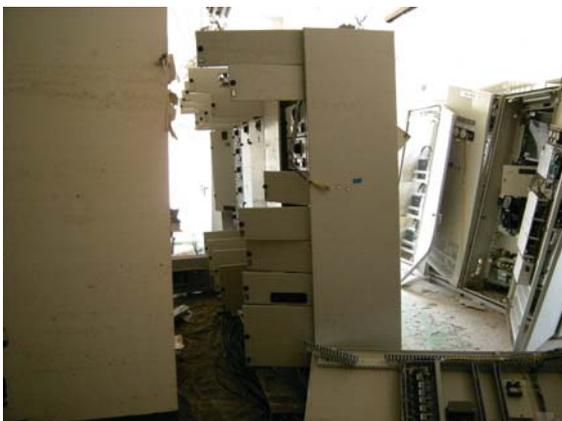
**Photo. 5.3** Damaged electrical room (Photo taken in Apr. 2011)  
Electrical equipment was inundated or destroyed by the Tsunami

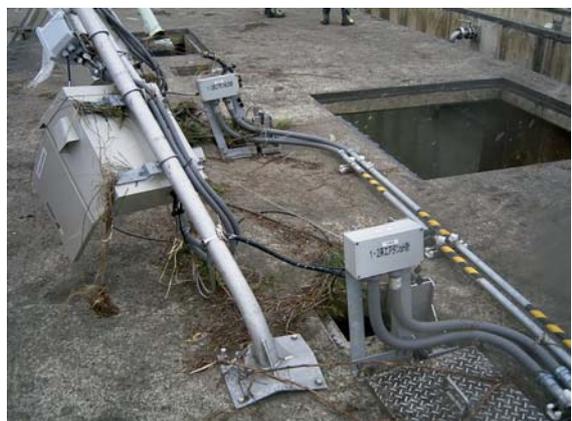
**Photo. 5.6** The destroyed pH meters for Aeration Tank No. 1 and 2 (Photo taken in Apr. 2011)  
Mounting pole destroyed by the Tsunami

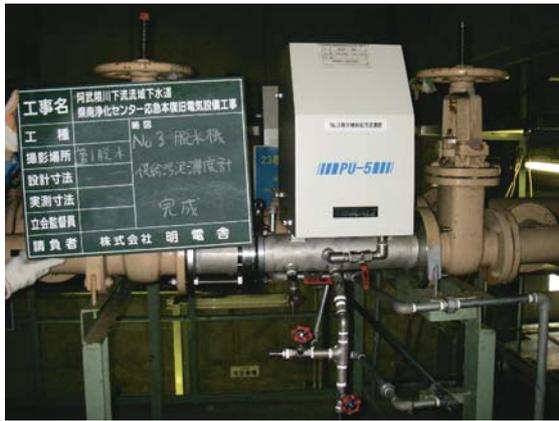
**Photo. 5.7** Restoration status of supplied-sludge density meter for No. 3 dehydrator (Photo taken in Oct. 2011)  
The equipment in the No. 1 dehydrator building was the first to be restored.
