# EICA Report of the Great East Japan Earthquake Investigation

April 2012

GREAT EAST JAPAN EARTHQUAKE INVESTIGATION COMMITTEE  
THE SOCIETY OF ENVIRONMENTAL INSTRUMENTATION,  
CONTROL AND AUTOMATION (EICA)

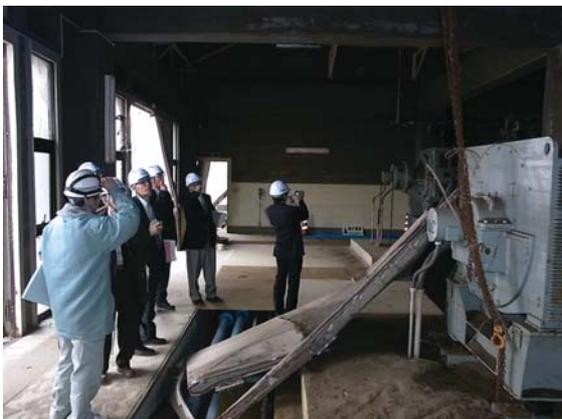
**Photo. 1.1** Survey conducted at the emergency generator room in Ken-nan STP (Photo taken in Nov. 2011)

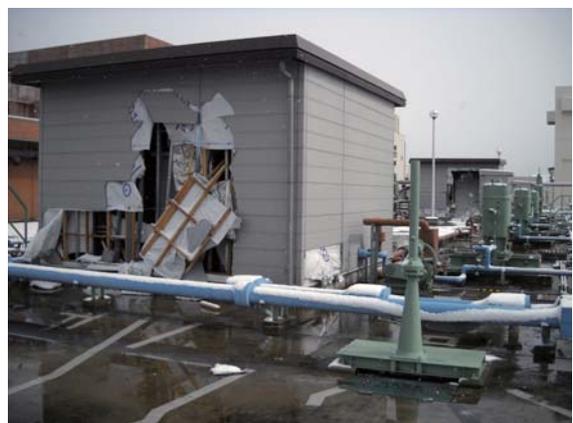
**Photo. 2.6** Upper part of the outdoor biological reactor tank on the 2nd floor of the building (Photo taken by staff member at the sewage treatment plant in Mar. 2011)

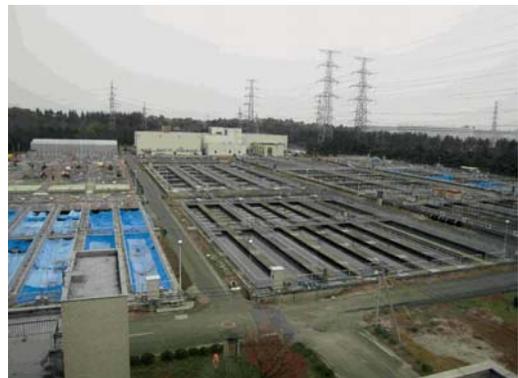
**Photo. 3.6** The water treatment facilities (Photo taken in Nov. 2011)

The section covered with the blue sheet is the temporary storage yard for the sludge of tsunami.

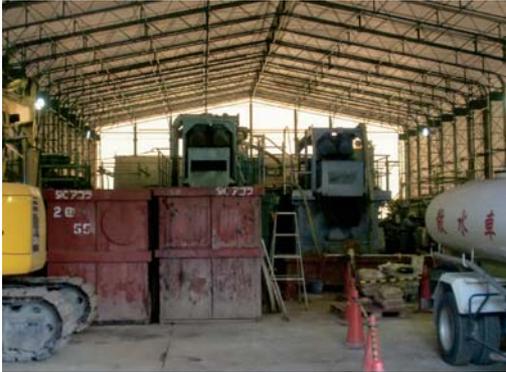
**Photo. 3.7** The temporary dehydrator (Photo taken in Nov. 2011)  
Sludge brought about by the tsunami is treated using the temporary dehydrator.

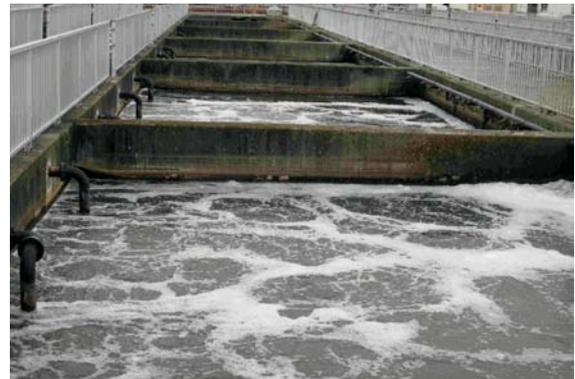
**Photo. 3.11** Simple aeration (Photo taken in Nov. 2011)  
Simple aeration, that means aeration without return sludge, was performed temporarily

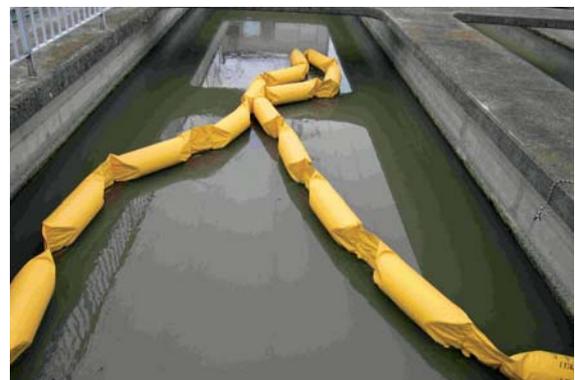
**Photo. 3.12** The disinfection tank (Photo taken in Nov. 2011)  
Disinfection was performed strictly for sanitation.

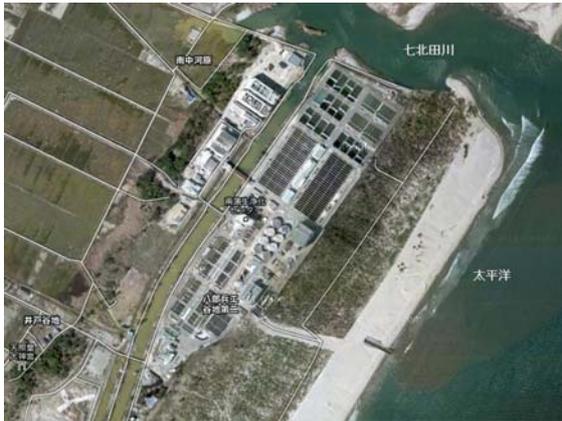
Minami Gamo STP is located at the right side bank of the estuarine of Nanakitada River in Sendai city. The plant is facing the Pacific Ocean and Teizan canal cuts across the plant field. (Photo. 4.1)

Photo. 4.1 Aerial photo of Minami Gamo STP. Tsunami came from southeast direction.

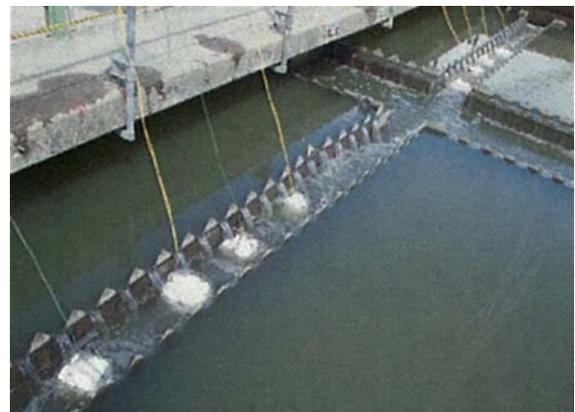
**Photo. 4.11** Disinfection with solid chlorine

On March 18, 2011, rubble in the STP was removed and water in the primary sedimentation tank was drained. Solid chlorination disinfection had begun right after (Photo. 4.11) and about one month later, on April 14, 2011, injection of sodium hypochlorite had begun. (Photo. 4.12) After that, sewage could be

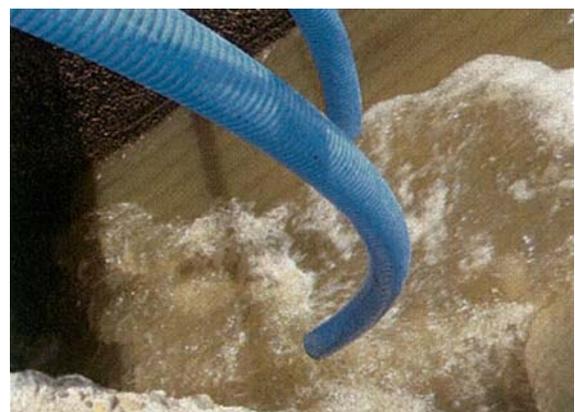
**Photo. 4.12** Injection of hypochlorous acid in temporary facility

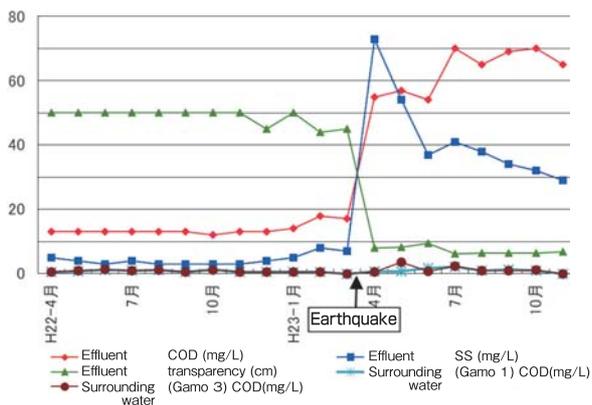
**Fig. 4.2** Influence on the effluent water by the earthquake disaster (x axis is month, y axis is mg/l)

The effluent water quality during this treatment is shown in the **Fig. 4.2**. The level of COD and SS largely went down right after the disaster, but improvement of SS was seen after the primary treatment had begun. Furthermore, water quality deterioration at the environmental standard place was not observed. The major reason being considered for this is the diluting effect by effluent to the Pacific Ocean.

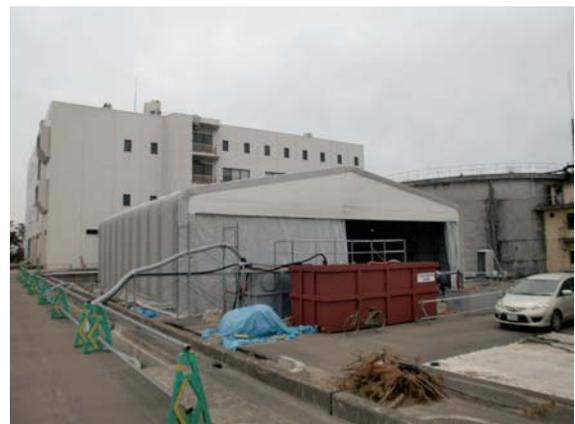
**Photo. 4.13** Temporary dehydrator housing. (Photograph taken in May 2011)

Temporary tent house was set up and equipment was installed inside.

The sludge treatment resumed sludge extraction from the primary sedimentation tank and also sludge treatment in the temporary dehydrator housing. (**Photo. 4.13**) After the introduction of the backup high voltage substation facility in middle of May 2011,

treatment of generated sludge resumed with existing centrifugal dehydrators through the temporary sludge pump.

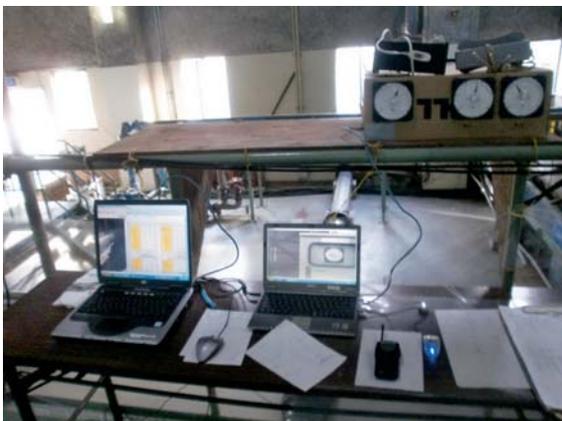
**Photo. 1** A temporary monitoring control system of dehydrator which consists of a notebook PC and instrumentation attached to card box. (Date Taken : October 2011 at Sen-En STP)

Because of this, different countermeasures had to be applied on each restoration work. For example, **Photo. 1** shows a damaged site where an inventive approach was needed to improve the conditions. They were able to make a temporary monitoring control system of the dehydrator in a short amount of time. **Photo. 2** shows a temporary sedimentation pond which was designed based on the experience from Niigata-Chuetsu Earthquake.

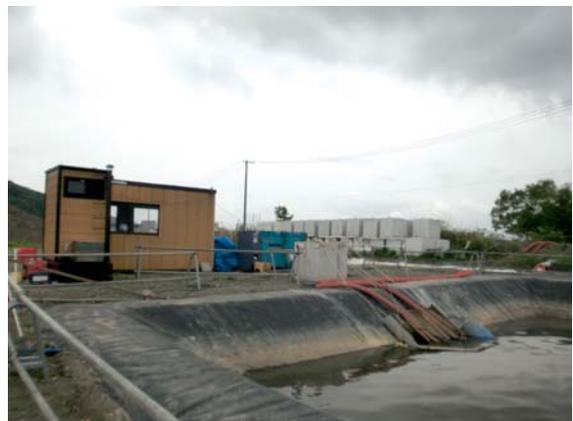
**Photo. 2** A temporary sedimentation pond and discharge pump was installed near the watershed of the Kyuukitakamigawa River to treat sewage water right after the earthquake. (Date Taken : May 2011 at near Ishinomaki Tobu STP)
